***Proceedings of the
3rd International Conference
on Conduction and Breakdown
in Solid Dielectrics***

STUDIES OF EPOXY SPACERS SUBJECTED TO INTERNAL AND EXTERNAL PARTIAL DISCHARGE AND SF₆ BYPRODUCTS

J.M. Braun, F.Y. Chu and A. Tyman

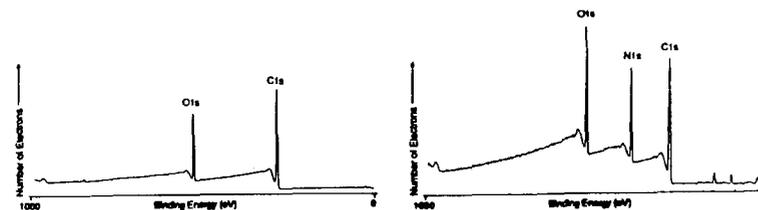
Figure 1. ESCA Scans of Epoxy Void Walls as Made (Left) and after PD.

Voids were subjected to pd by encapsulating the above specimens between two electrodes. Early changes in void wall chemistry were probed on large (5 mm diameter) voids by ESCA (Electron Spectroscopy for Chemical Analysis). A typical spectrum obtained on the surface of a fractured void exposed to 48 hrs. of sustained pd is given in Figure 1, illustrating the sharp rise in nitrogen. The binding energy of the nitrogen peak (N1s) is consistent with the incorporation of the nitrogen into the epoxy as an amine. Given the high surface concentration of nitrogen (30 surface-%), substantially all nitrogen would have been reacted in the void. The ESCA technique is sensitive enough to detect changes in wall chemistry, long before SEM could find evidence of wall erosion. We are planning on using this approach to study the lower size limit at which pd can be considered harmless. Investigations are also underway to determine the corresponding pressure changes in the cavity as well as changes taking place in volatile organics in the void atmosphere. PD inception and extinction voltages, pulse magnitude and repetition rates, with and without X-ray irradiation were also determined and were reported earlier [4].

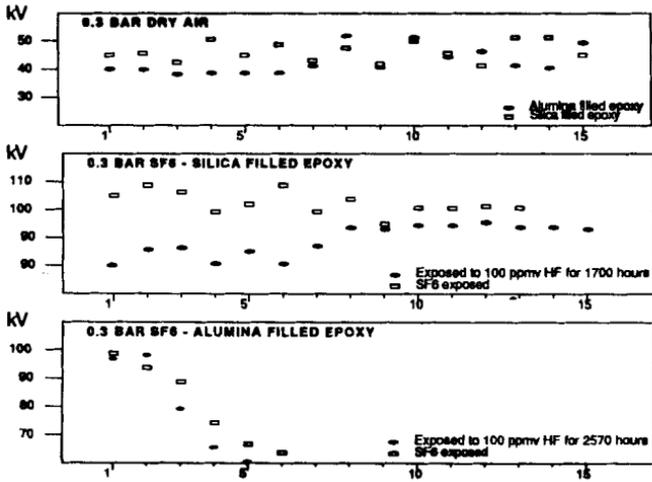
Figure 2. Dielectric Withstand Voltage of Filled Spacers Samples Exposed to Decomposition Byproducts

down strength in both air and SF₆ (energy of about 10 J) as described in detail elsewhere at higher byproduct concentrations [6]. Typical results of the exposure experiments are shown in Figure 2. A significant drop in the dielectric withstand of the sample occurred in the silica filled material after exposures of 1700 hrs. By comparison the alumina filled material was virtually unaffected by low level exposure to HF but underwent progressive deterioration in withstand voltage on subsequent impulses. Interestingly this decrease was only observed in SF₆ and not in air. The decrease is believed to be related to the change in surface chemistry (incorporation of S and F moieties into the epoxy chain) that we reported in earlier studies [5,6].

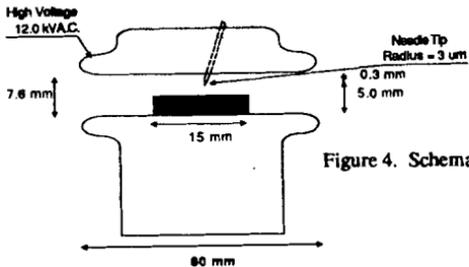
Figure 4. Schematic of Experimental Setup

The effects of localized, low energy electrical discharges on dielectric surface degradation were investigated with the experimental setup of Figure 4 to simulate the above process. The voltage was raised to a level such that partial discharges were starting to occur from the sharp (3 μm diameter) tip of the needle. The samples were then aged under these conditions in an SF₆ atmosphere. Dielectric withstand and physical characterization were performed on the aged samples.
